Re: Rim Columbus Inspection Report Response (M/037/0006)

**ATTACHMENT A
UPDATED FIGURES**

**ATTACHMENT B
PHOTOGRAPHIC DOCUMENTATION**

Denison Mines (USA) Corp.
Rim/Columbus Photographic Log
October 27, 2008

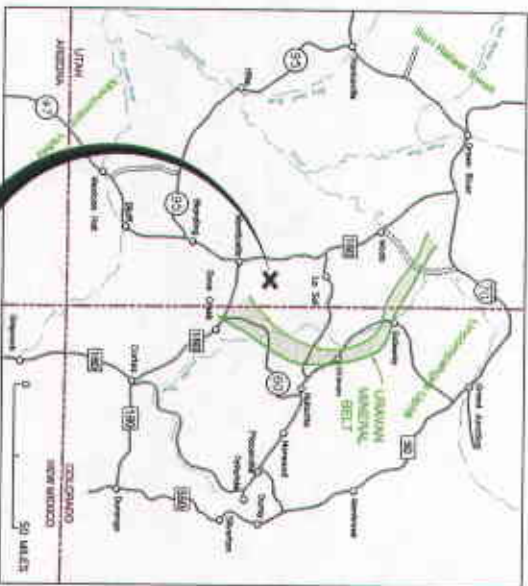
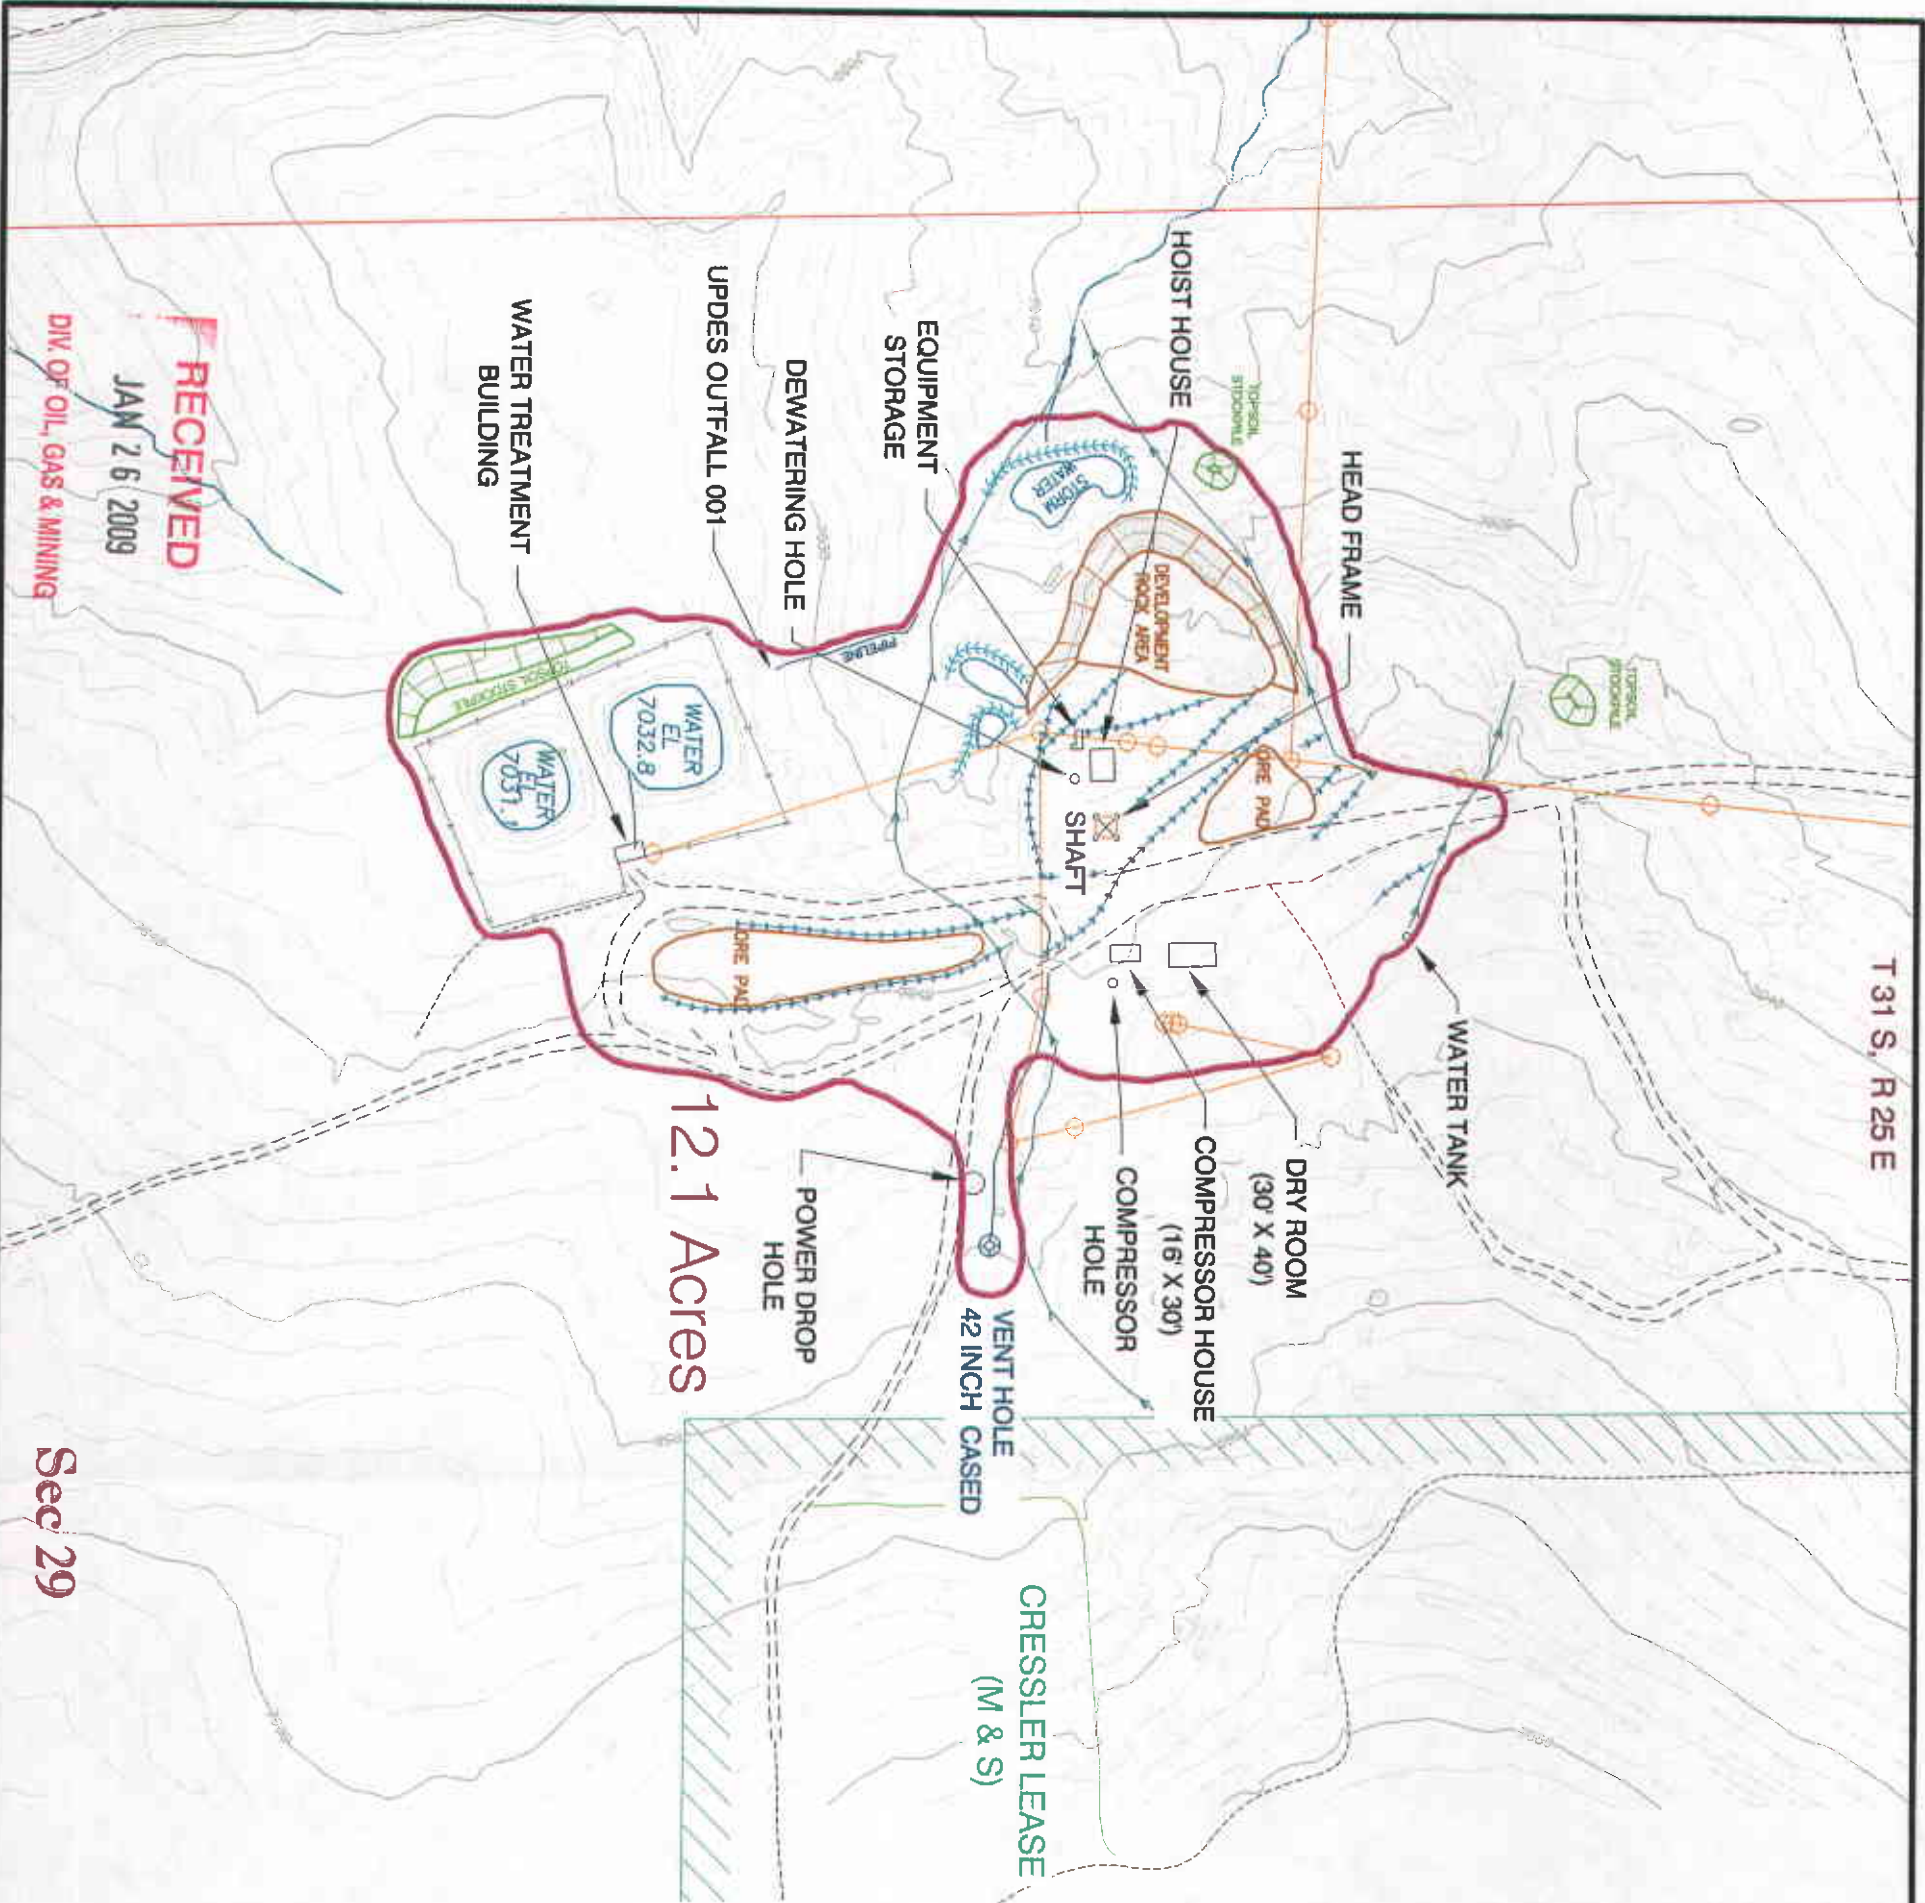
Figure 2

RIM SHAFT, HUMBUG PORTAL
AND COLUMBUS PORTAL M/037/006

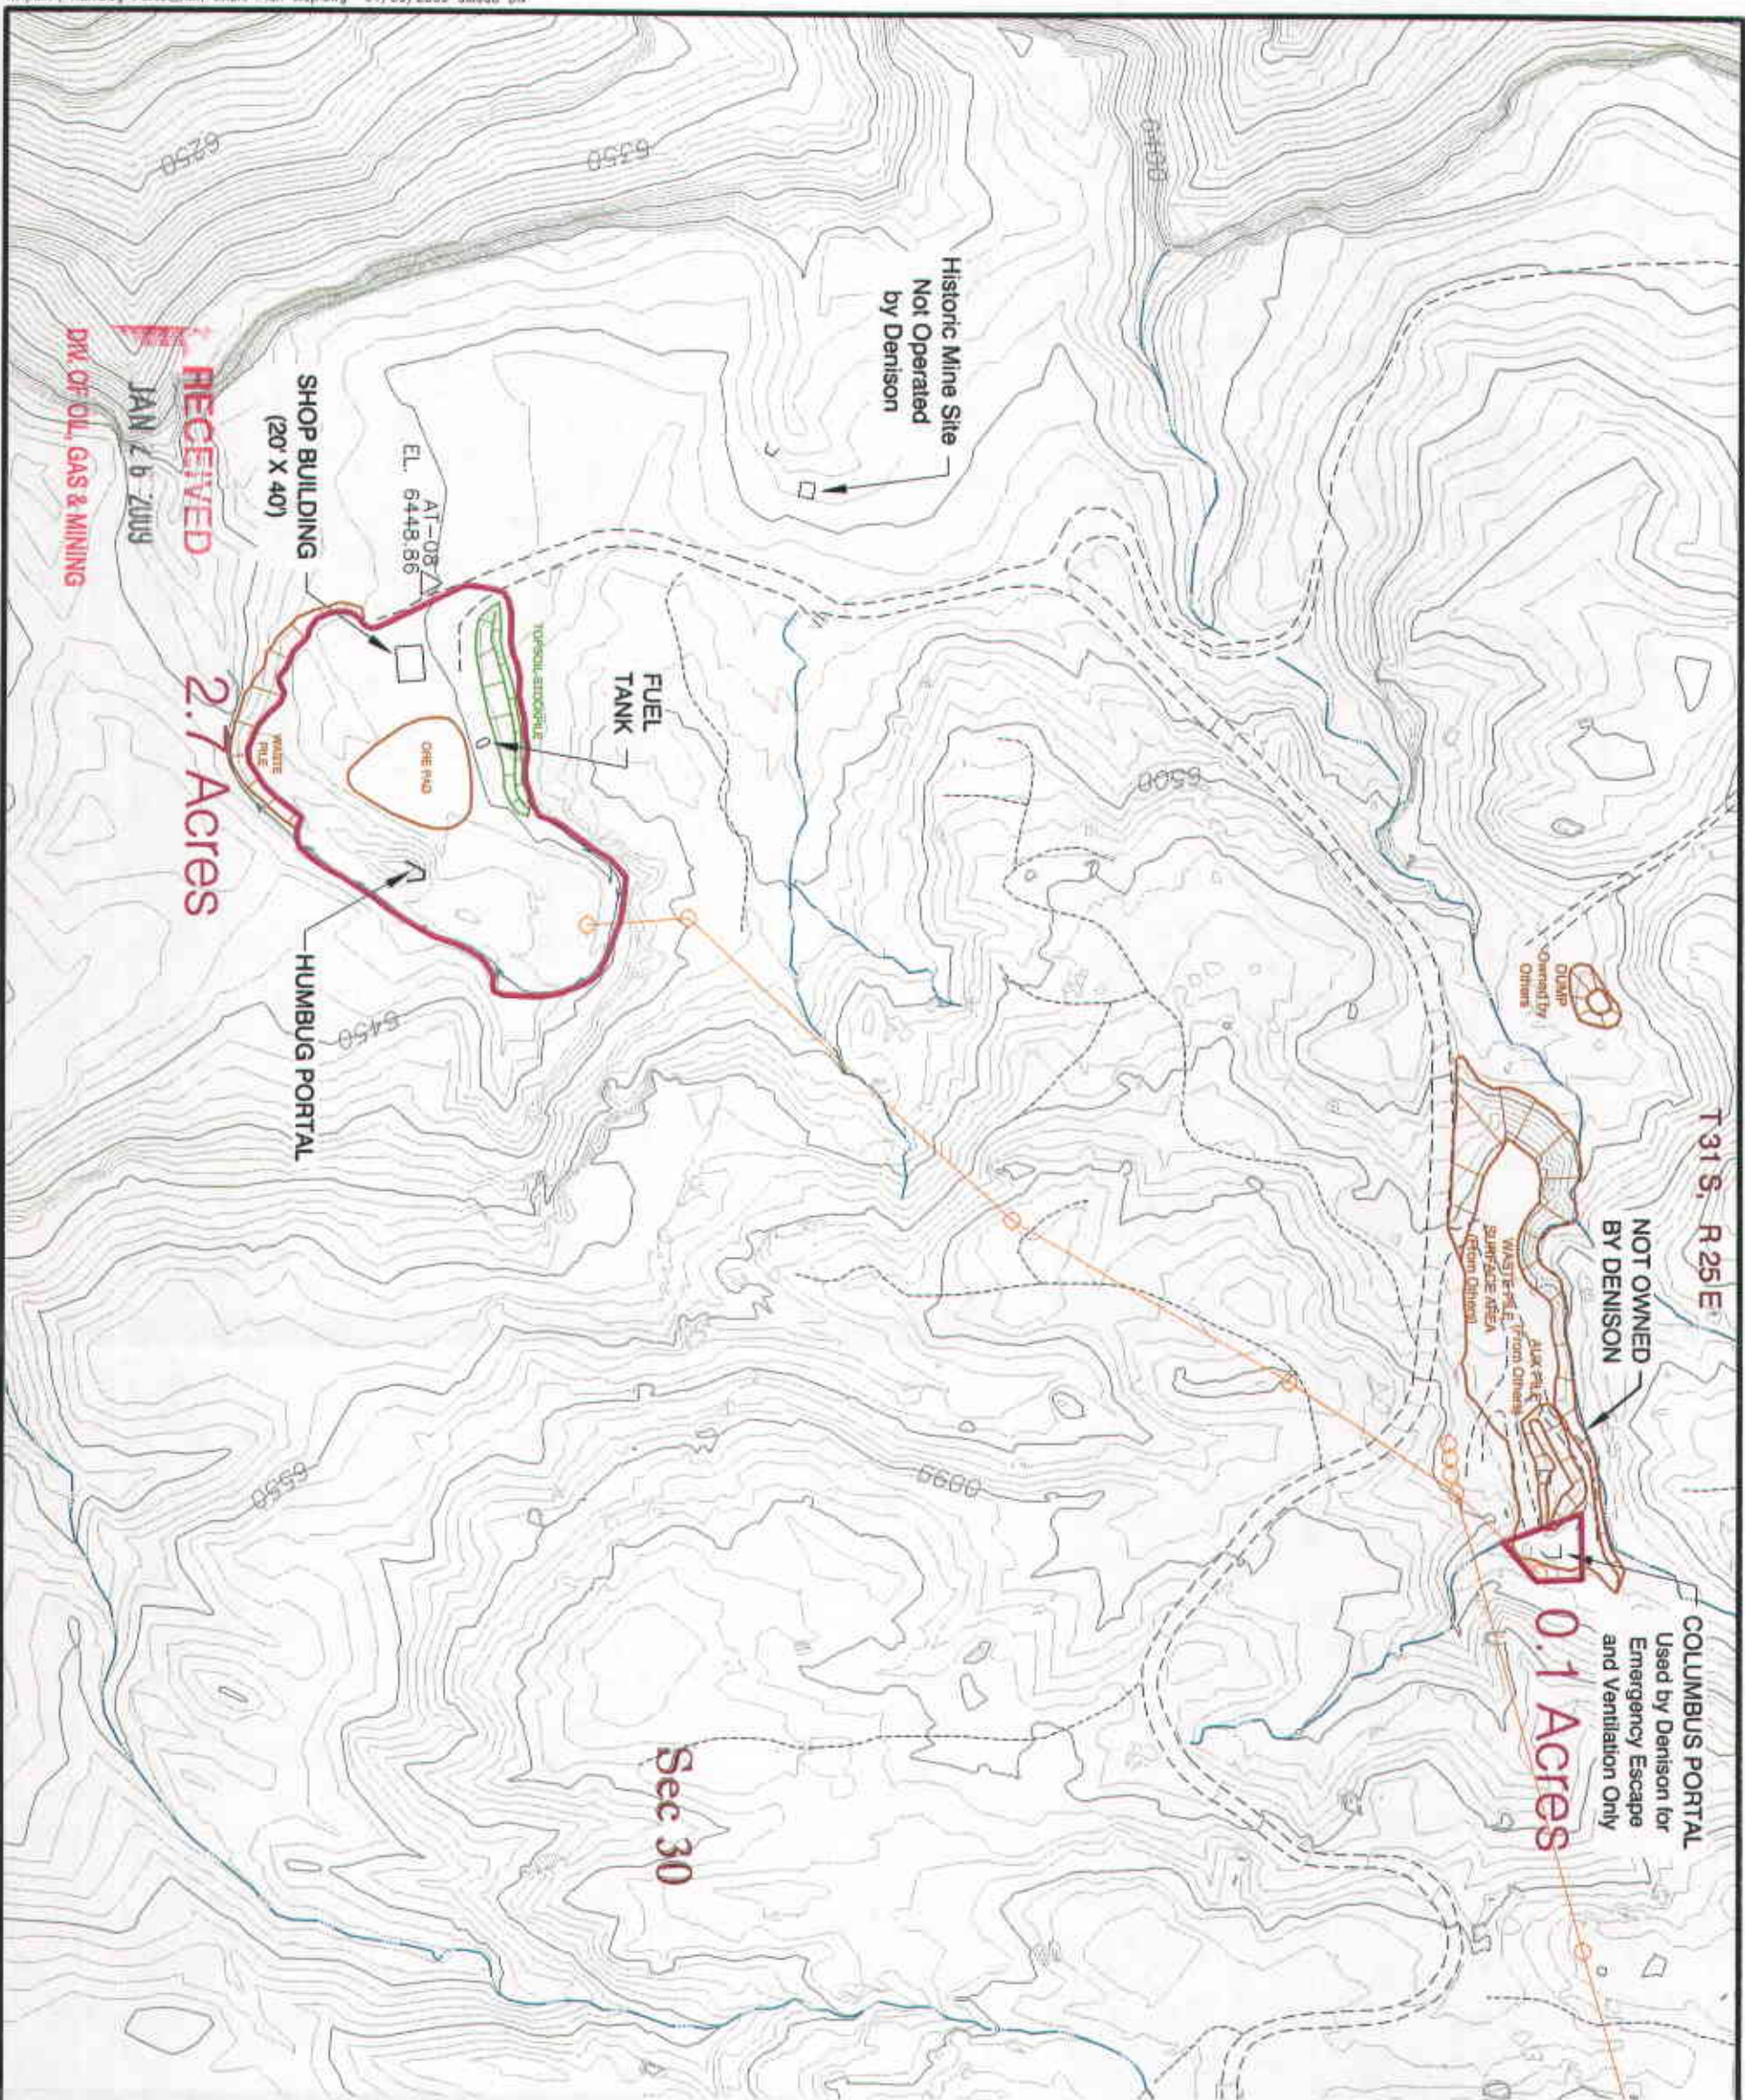
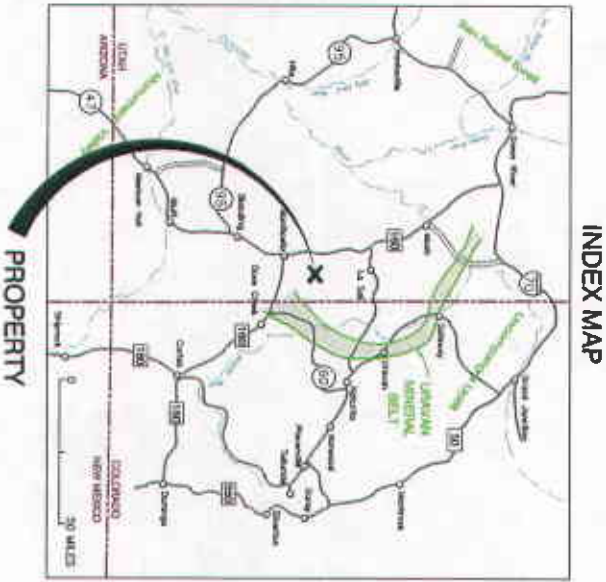
Denison Mines (USA) Corp.				DENISON MINES	
REVISIONS		Project:	RIM-COLUMBUS MINE PROPERTY		
Date	By	County:	San Juan	State:	Utah
12/31/08	DLS	Location:	Section 29, T 31 S, R 25 E		
				Figure 3	
				RIM SHAFT	
				SURFACE FACILITIES MAP M/037/006	
		Author:	CW	Drawn By:	Stodd

TOTAL AREA RIM SHAFT = 12.1 ACRES
